THE FALKLANDS: THE DIARY OF A NAVAL CONSTRUCTOR

By Constructor Commander R. K. Pudduck
Ceng, MRINA, RCNC Fleet Naval Constructor Officer (1982)

This article is reprinted from the January 1983 edition of Review of Naval Engineering, as a reminder of the engineering efforts made by those who fought on, under and over the South Atlantic in 1982.

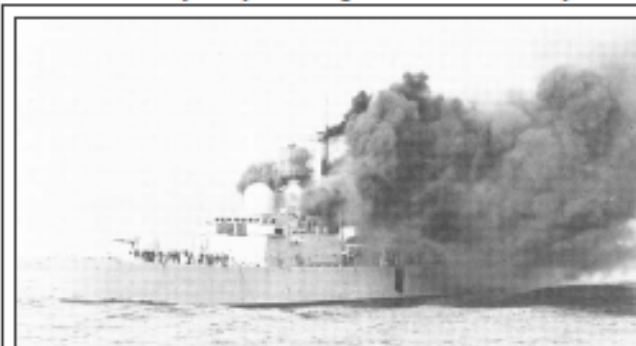
Figure 1: HMS Sheffield shortly after being hit by an Exocet missile

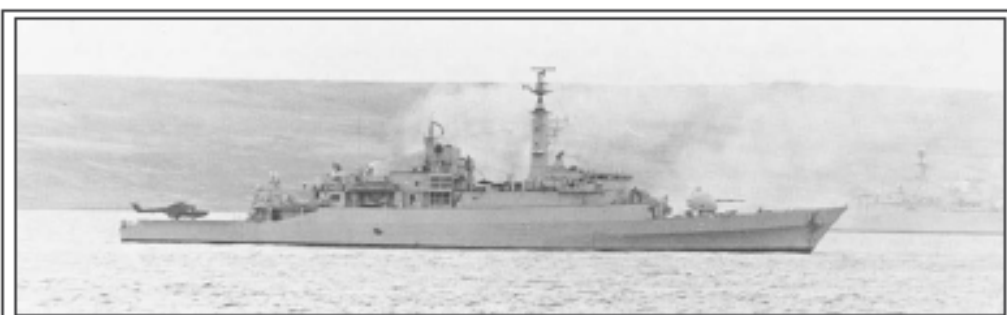
Figure 2: HMS Antelope limps into San Carlos Water: entry hole of unexploded bomb is visible below funnel

On returning to *Hermes* there was concern over *Antelope* which had been hit by two UXBs. *Arrow* was sent to San Carlos to replace *Antelope*, and the calmer water

there would reduce the strain on her damaged hull. Later – bad news that one of *Antelope*'s bombs had exploded whilst being defuzed.

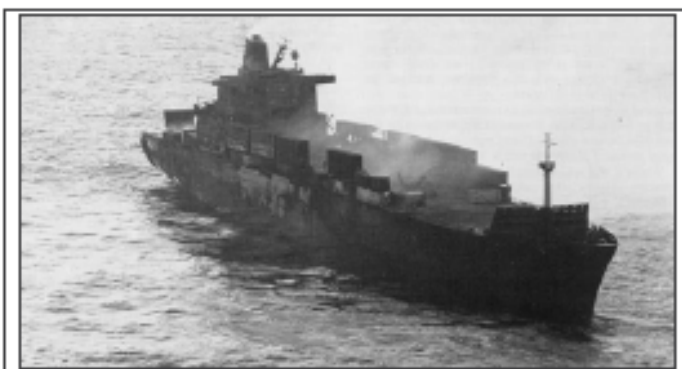
Figure 3: Atlantic Conveyor burning after being hit by an Exocet missile

26th May. At 19 30 *Atlantic Conveyor* hit by two Exocets. Forty-five survivors brought to *Hermes* from *Atlantic Conveyor*, mostly heloed direct from the fo/c's'le. Some personnel lost their lifejackets because they were not tightly secured when they jumped into the sea. Few had warm clothing and hypothermia certainly took its toll. *Alacrity* and *Brilliant* assisted in the rescue, but fire fighting efforts were useless. By next day she was a smoking wreck with explosions continuously tearing her inside out.

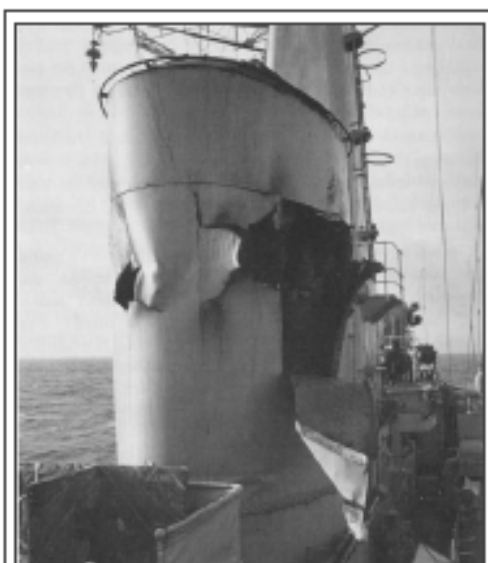
Figure 4: HMS Plymouth's funnel damage by 'something' that hit her during the action on 8th June

Visited Plymouth 9th June. Another case of UXBs. One passed through the crew's shelter, aft of the mortar. The second entered the mortar handling room 10 feet above the waterline, was deflected up through the loading compartment, struck the mortar, and flew away over the starboard side. There was no fire or explosion. Apart from patching the ship's side, the most serious problem was live, shocked mortars in the crimped barrels and others trapped on their racks by seized doors.

The second area of damage was caused either by shrapnel or by another bomb striking a depth charge which exploded on the starboard edge of the flight deck. This slightly damaged the Wasp and caused a serious fire in the PO's mess below. The fire spread into the junior ratings' dining hall and passageway, before being extinguished by determined efforts by the fire parties. The fire damage was mainly cabling insulation. It took time to isolate and provide enough emergency leads to the after end services, and a number of minor electrical fires broke out sporadically for some hours after the major fire had been extinguished.

Plymouth also suffered some cannon and shrapnel damage, especially to the funnel casing which was badly holed, and in the 4.5 turret. Seaspread assisted with cleaning up the fire damage, restoring firemain, and making the electrics safe.

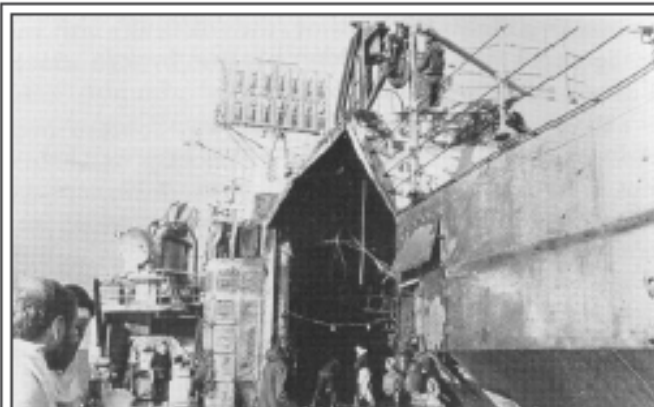
12th June. Glamorgan hit by suspected Exocet 0630 today. I transferred at noon to survey the damage. The damage to Glamorgan was arguably the most severe of all sustained by Task Force warships with the exception of those ships which subsequently sank. The explosion blew a hole in the weatherdeck approximately 20 feet by 8 feet with the longer dimension in the direction of the missile's approach, Red 150. The explosion plainly took place on the deck, blowing down into the galley, forwards along the waist, and inboard into the hangar. A fuel explosion in the hangar blew the doors and the already unseated Seacat launcher over the side.

The Wessex, containing much magnesium together with its fuel and small arms ammunition caused a fierce and hazardous fire taking two hours to extinguish. Success in controlling the fire was largely due to the ship's ability to provide quickly a considerable quantity of AFFF treated water. Accepting the theory that this was an Exocet fired at extreme range, there was no billowing smoke from unspent rocket fuel, and the major fire burnt on the open deck. Blast damage was considerable, reaching up to indent the port

Figure 5: HMS Glamorgan shortly after being hit by land-launched Exocet. The hole in the galley deckhead has been covered with plywood sheets

after quarter of the after funnel, and shrapnel damaged STWS tubes and holed the Cheverton. A fireball went down through the GT intakes and entered the GTCR and gear room causing sooting but no burning. In the galley the major damage was caused by blast and shrapnel. Casualties were heavy, caused by sharp flying metal, ceramic tiles and razor-edged silvers of formica. Although Glamorgan was in Defence Watches 2Y, the number of casualties would probably not have been less in 1Z since the cooks and stewards formed a first-aid party whose action station was in the passageway immediately adjacent to the galley – an area similarly devastated.

A two-foot diameter hole in the galley deck above M2 breaker room allowed firefighting water to flood down to 3 Deck passageway and 3R mess. Together with the flood in the Seaslug magazine caused by shock-fractured spray main, the ship at one stage developed an 11" roll.

With assistance from Stena Seaspread, 60 per cent of the galley was ultimately made usable. The deck was plated over and repairs were made to the G6, ODGS,

auxiliary boilers, fridge plant, and upper-deck hydraulics. Rewiring of burnt cables to the 901 was progressed, and the starboard Seacat made serviceable and the Seaslug magazine dried out. The whole operation stretched Stena Seaspread's capabilities to the full.

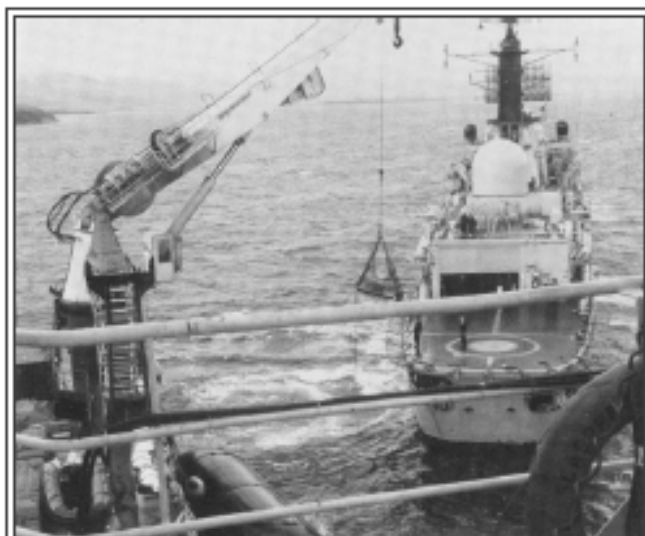
Figure 6: HMS Exeter being serviced by Stena Seaspread: the 100 ton crane in use. Note air filled Dunlop fender

29th June. To Stena Seaspread in San Carlos to examine hull cracks in *Ambuscade*. The next major task for NP 1810 was to change *Avenger's* broken propeller afloat, for which special tools were awaited. Meanwhile *Exeter* came alongside for an AMP, *Anco Charger* provided fuel, and H.M. S/M *Onyx* intermittently berthed on the other side. Dynamic-positioning Dunlop fenders and the 100-ton crane were being put to good use.
